ON-SITE AIR BAG INVESTIGATION

CASE NO. - 96-20
FLEET - PRIVATE VEHICLE
LOCATION -
ACCIDENT DATE - 1996

1996 Chevrolet Cavalier

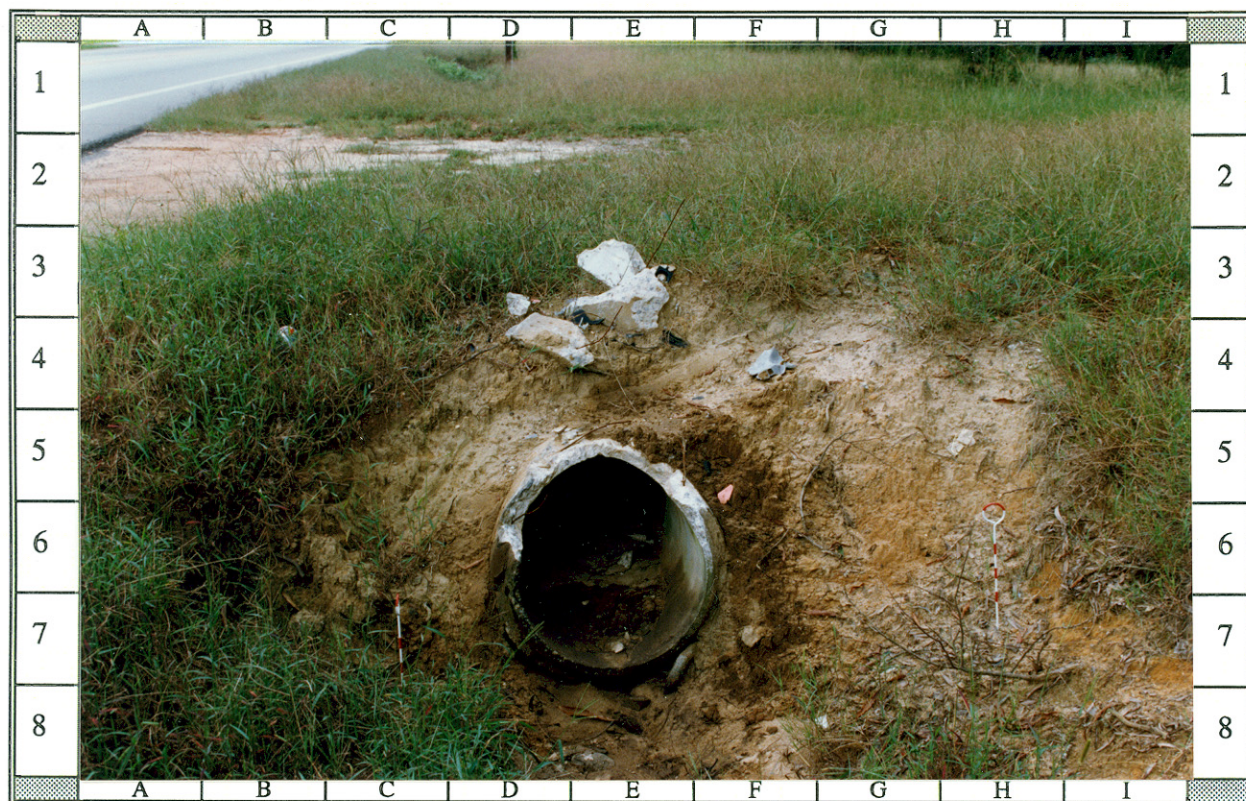
07: Southeastward view of impacted culvert and Case Vehicle's position at final rest;
NOTE: red/white stakes represent final rest positions of front tires

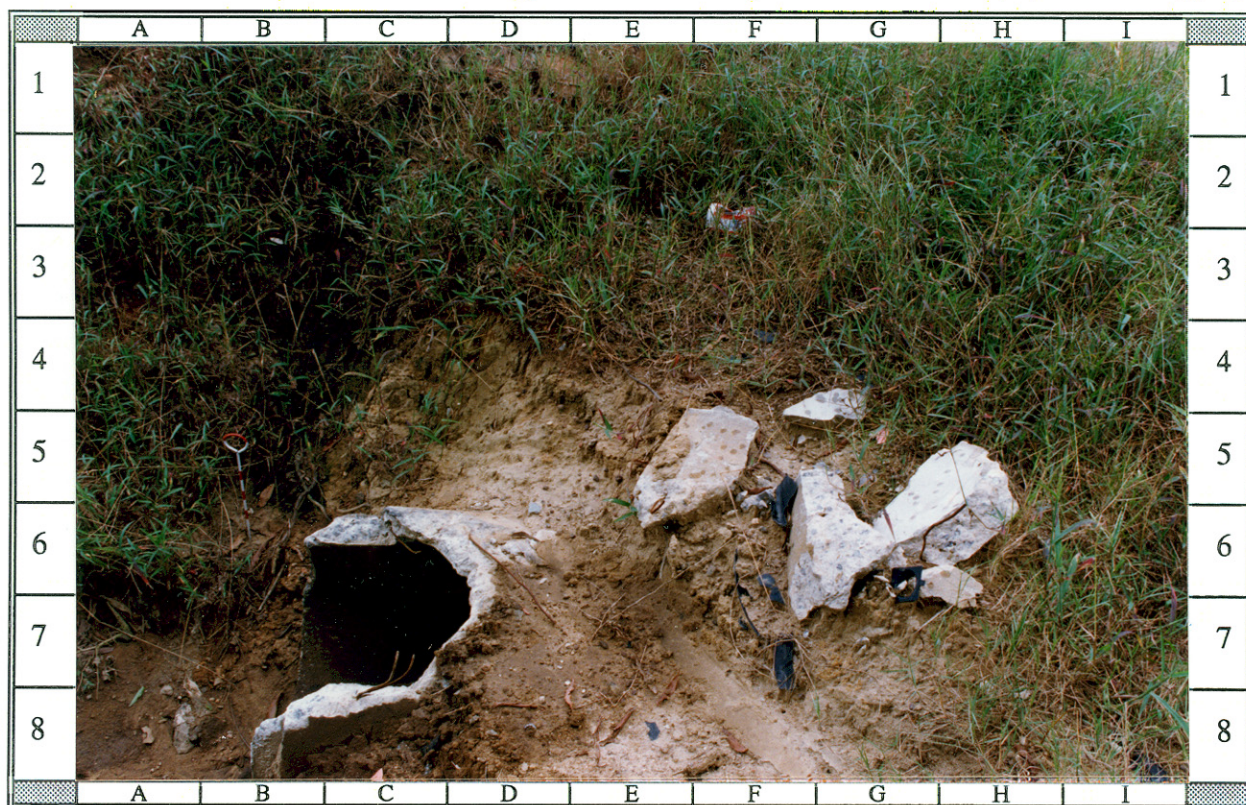
08: Northeastward view of damaged drainage pipe and debris from Case Vehicle;
NOTE: stake marks left front tire's final rest position

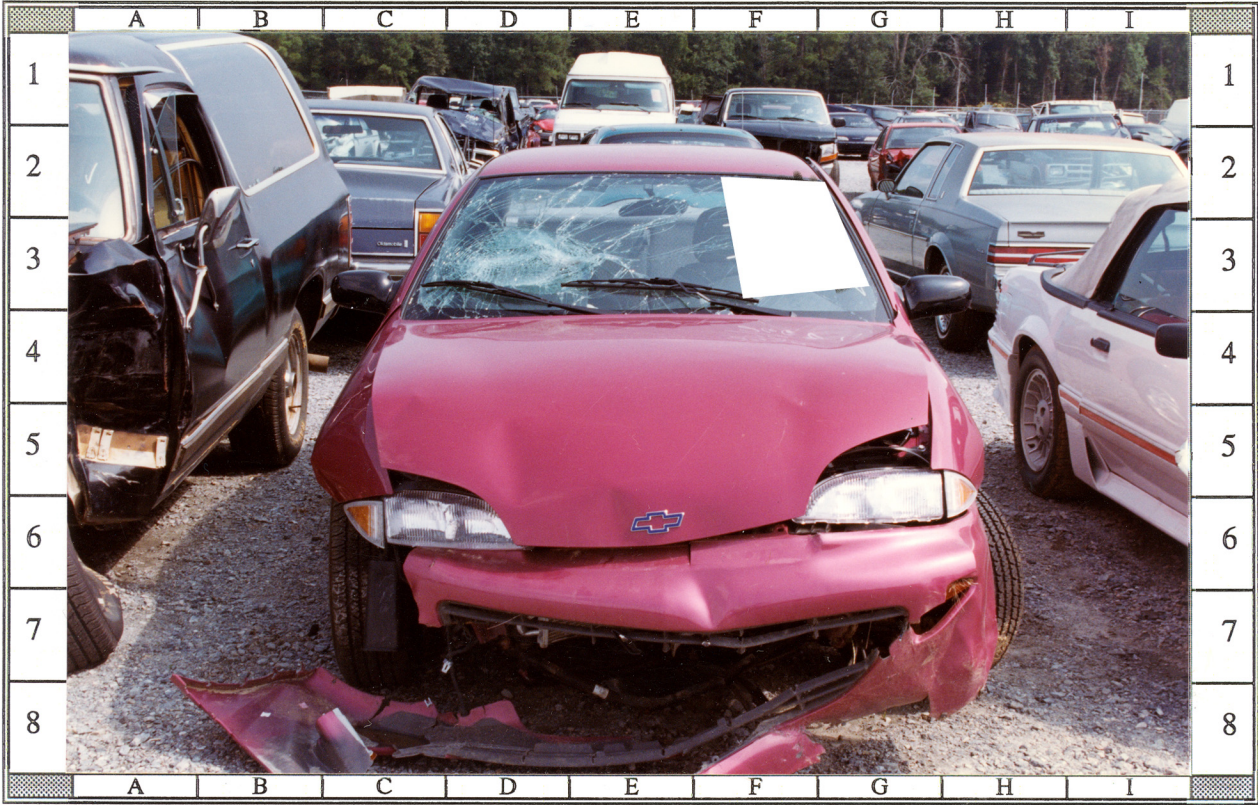
11: Case Vehicle's damaged front without contour gauge present; NOTE: damage primarily to bumper and below

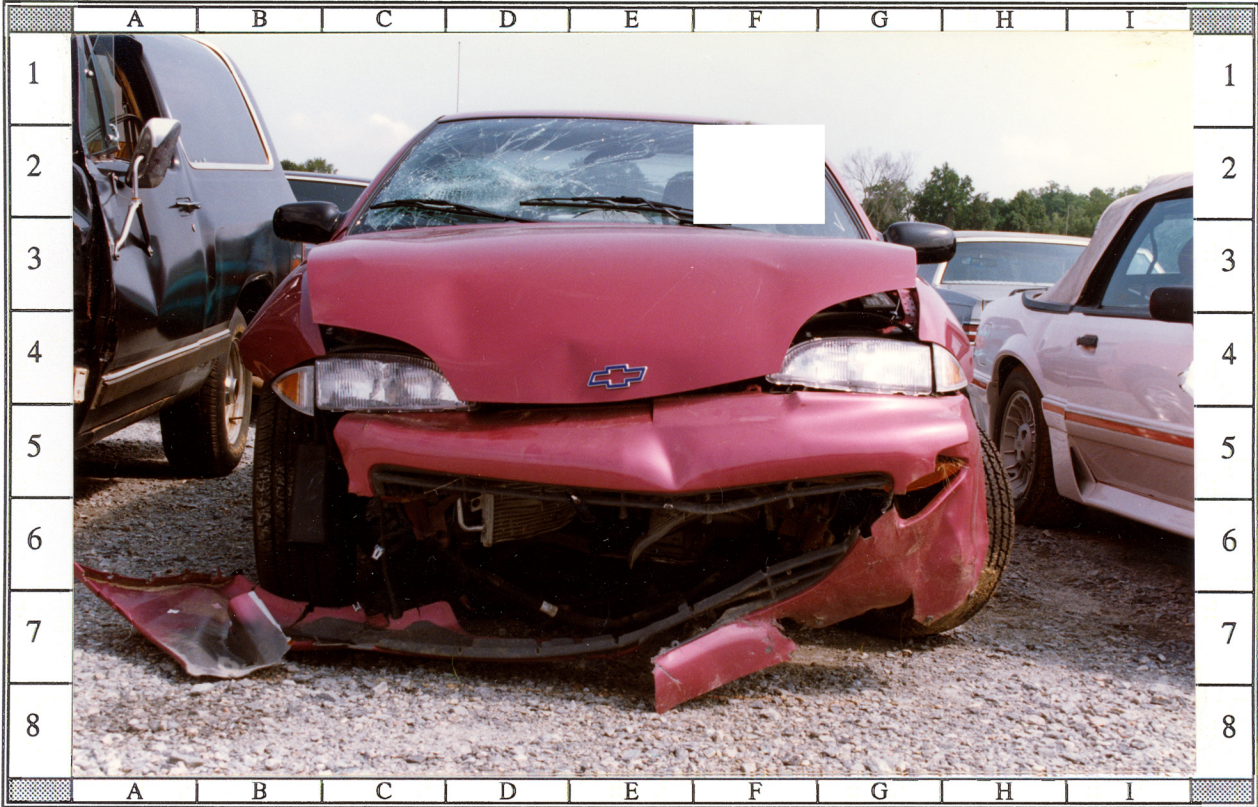
12: Case Vehicle's damaged front viewed from bumper level without contour gauge; NOTE: extensive damage below bumper

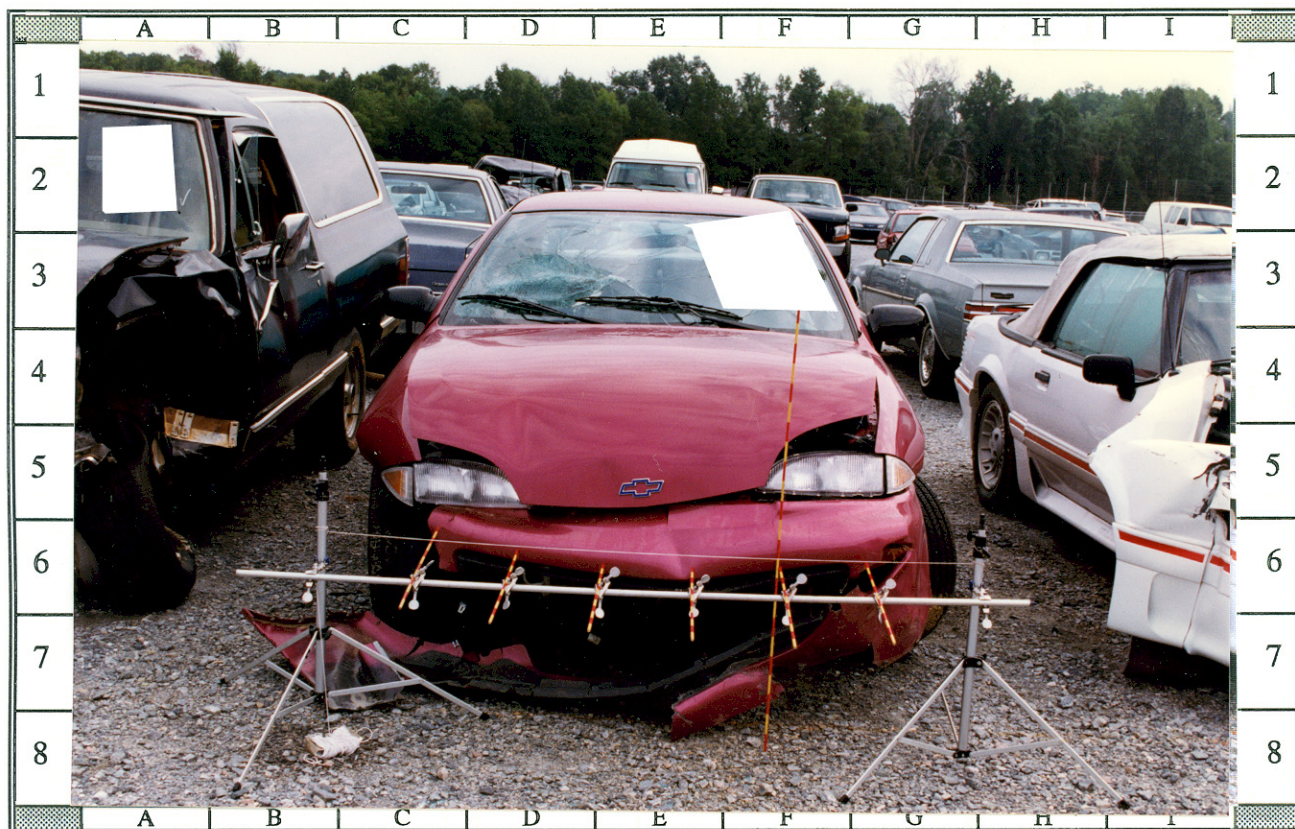
13: Case Vehicle's damaged front with contour gauge present at bumper level

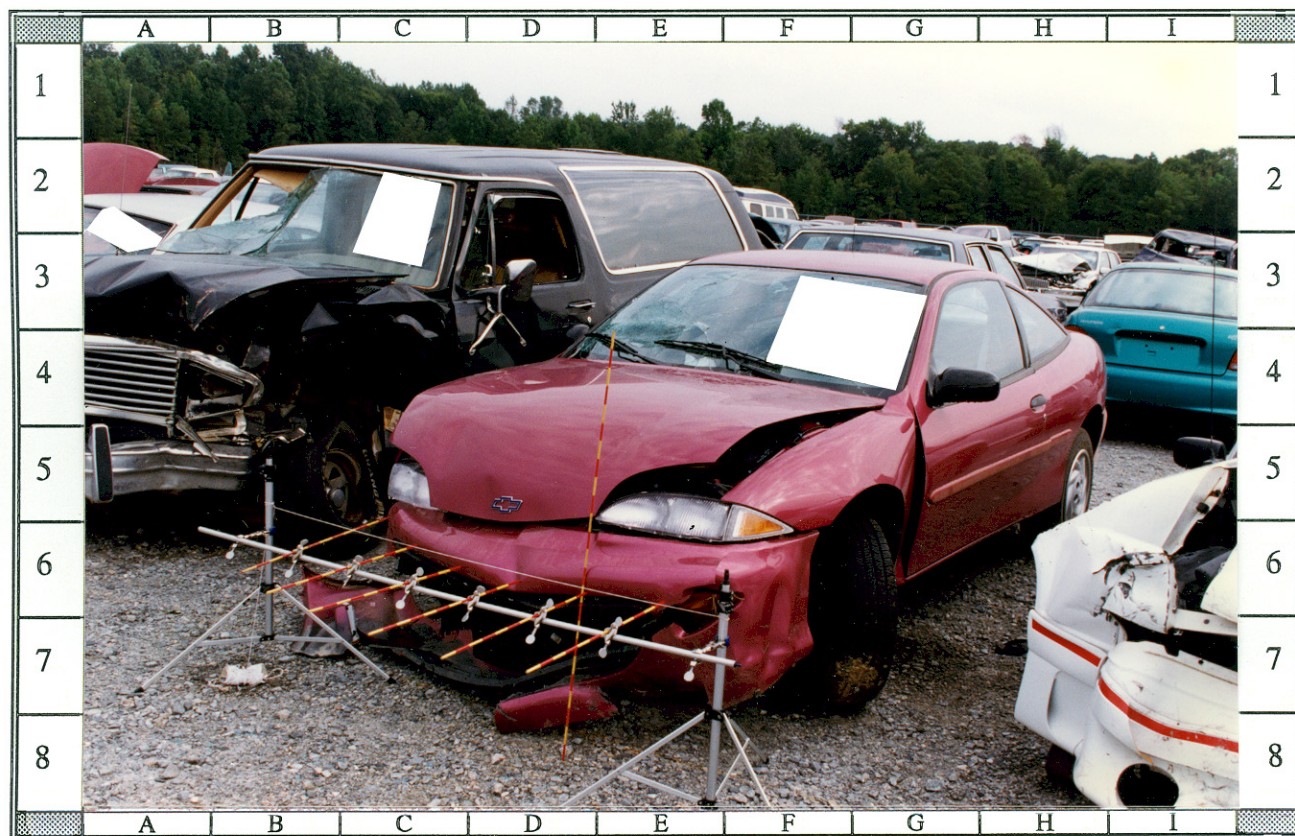
14: Case Vehicle's damaged front viewed from approximately 30 degrees left of front; NOTE: induced damage to hood and left fender

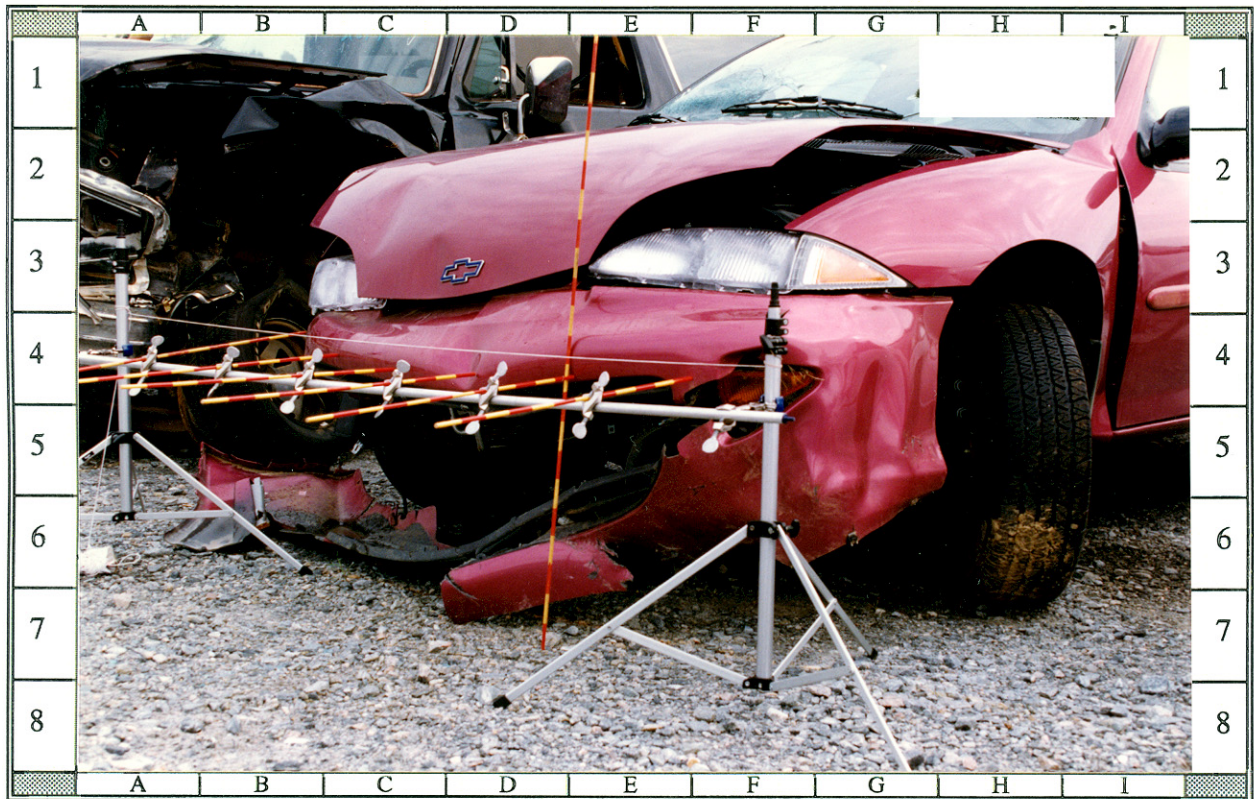
15: Close-up of Case Vehicle's damaged front viewed at bumper level from approximately 45 degrees left of front; NOTE: induced left fender damage near door

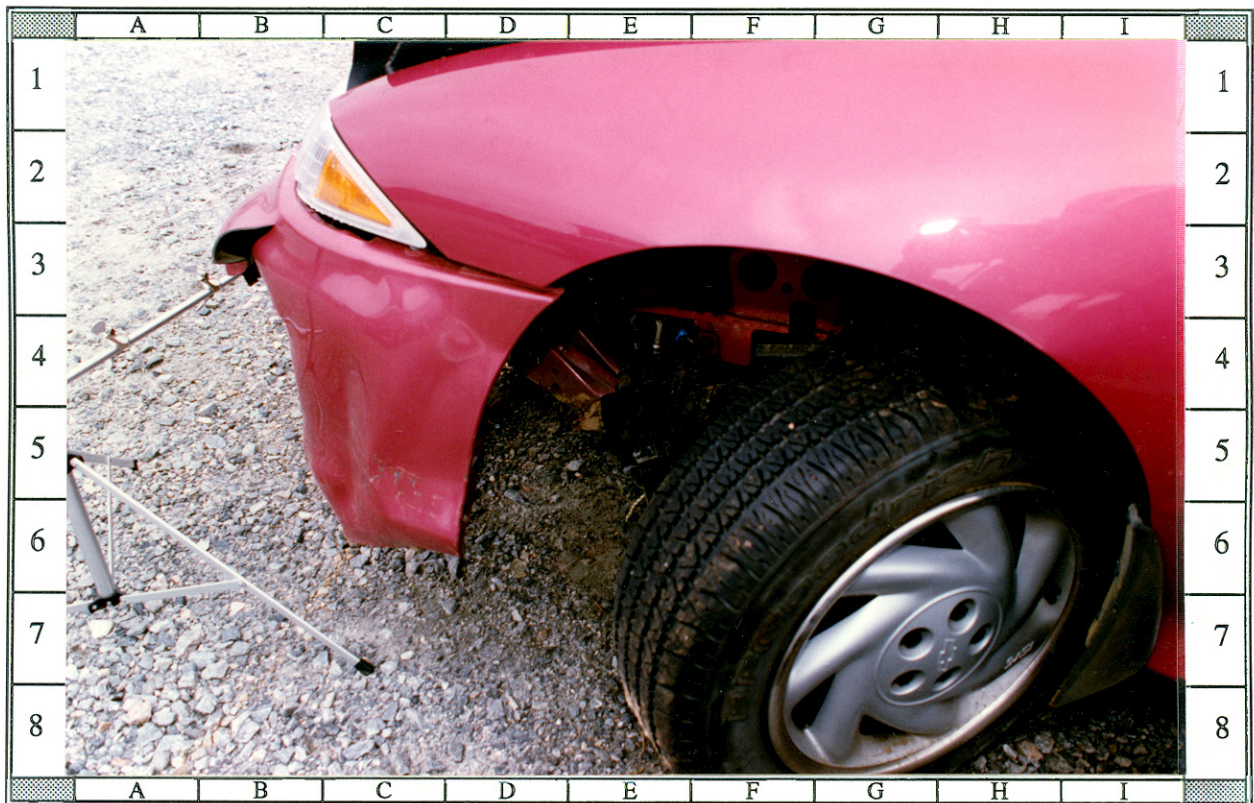
16: Close-up of Case Vehicle's damaged left front wheel assembly; NOTE: left front wheel shoved rearward

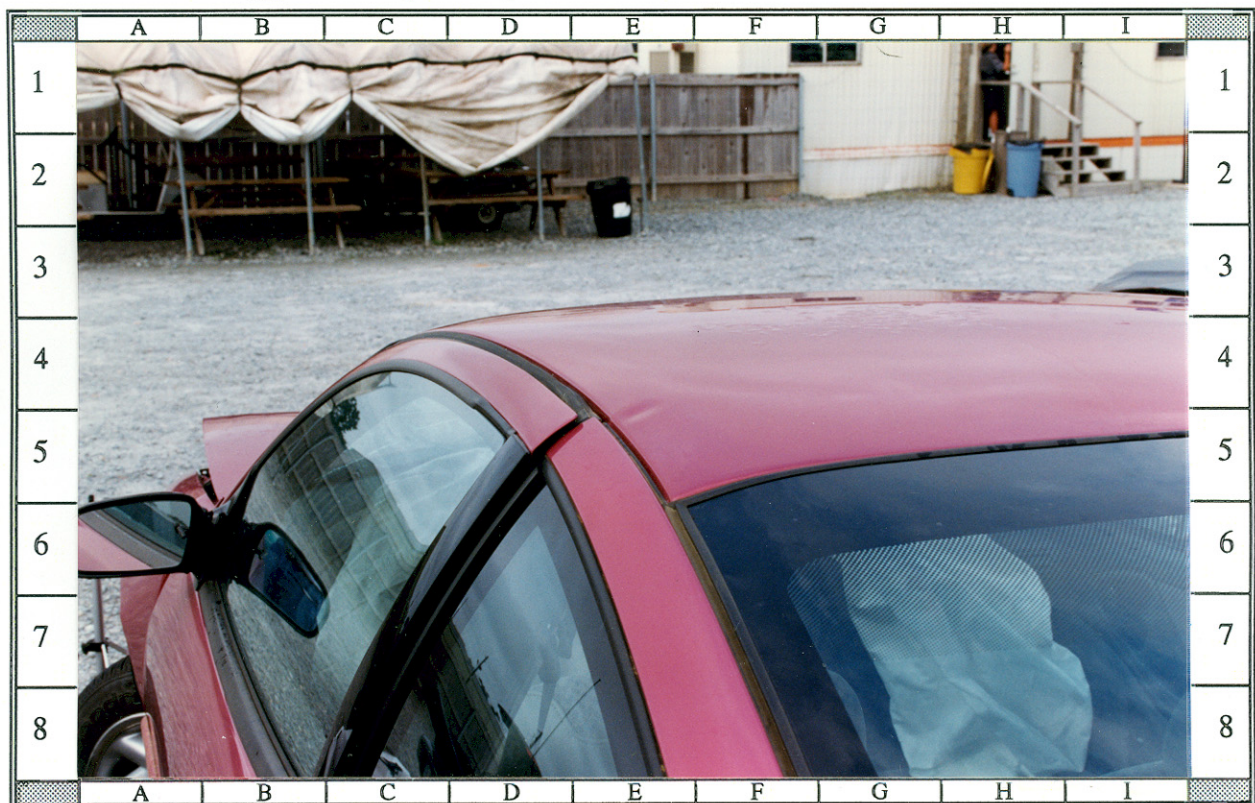
18: Close-up of buckling to Case Vehicle's left roof near "B"-pillar

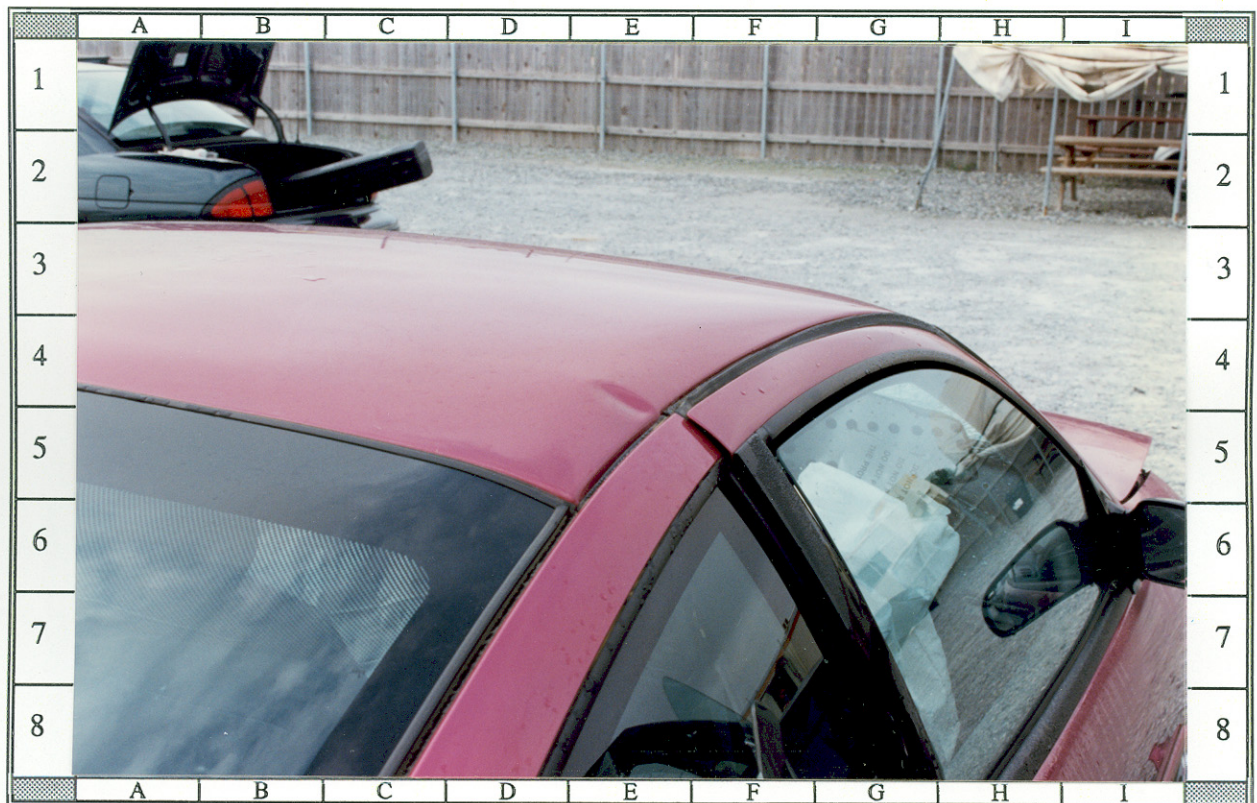
20: Close-up of buckling to Case Vehicle's right roof near "B"-pillar

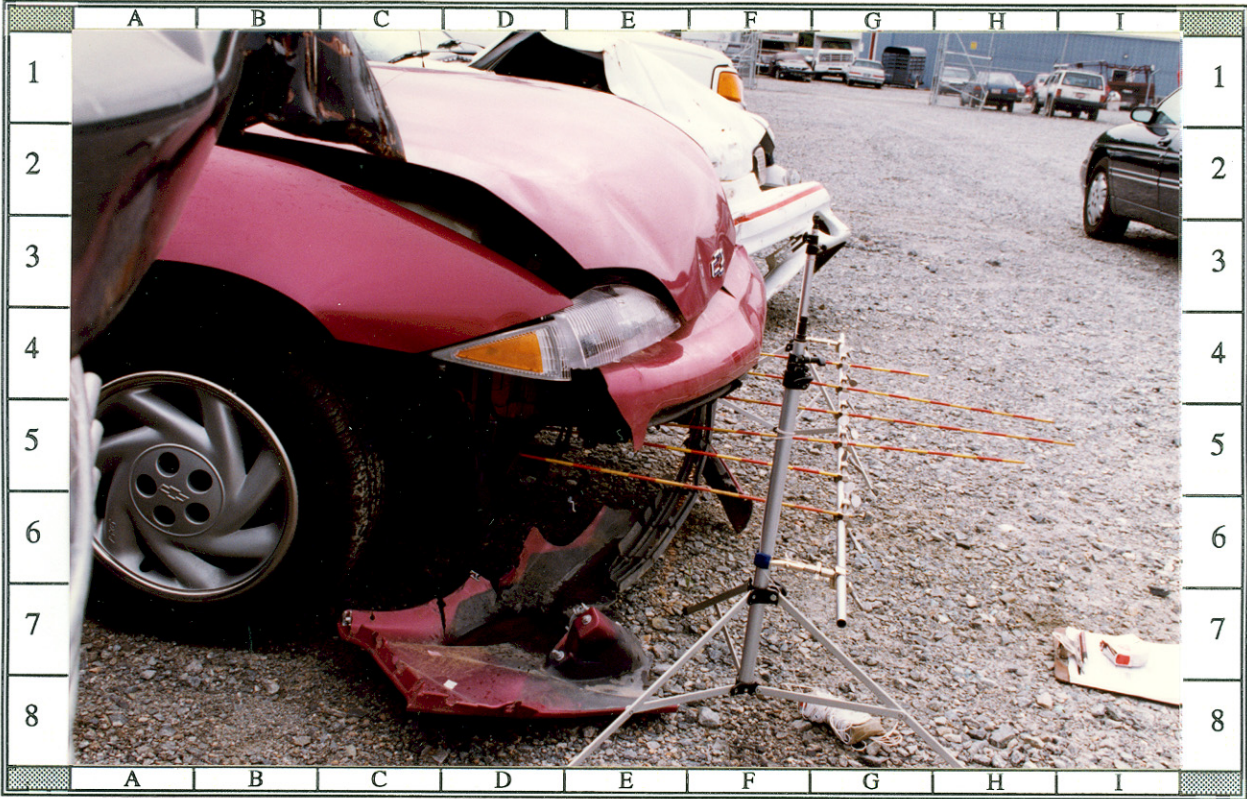
21: Reference line view of Case Vehicle's damaged front from right; NOTE: contour gauge placed and crush measurements taken below bumper

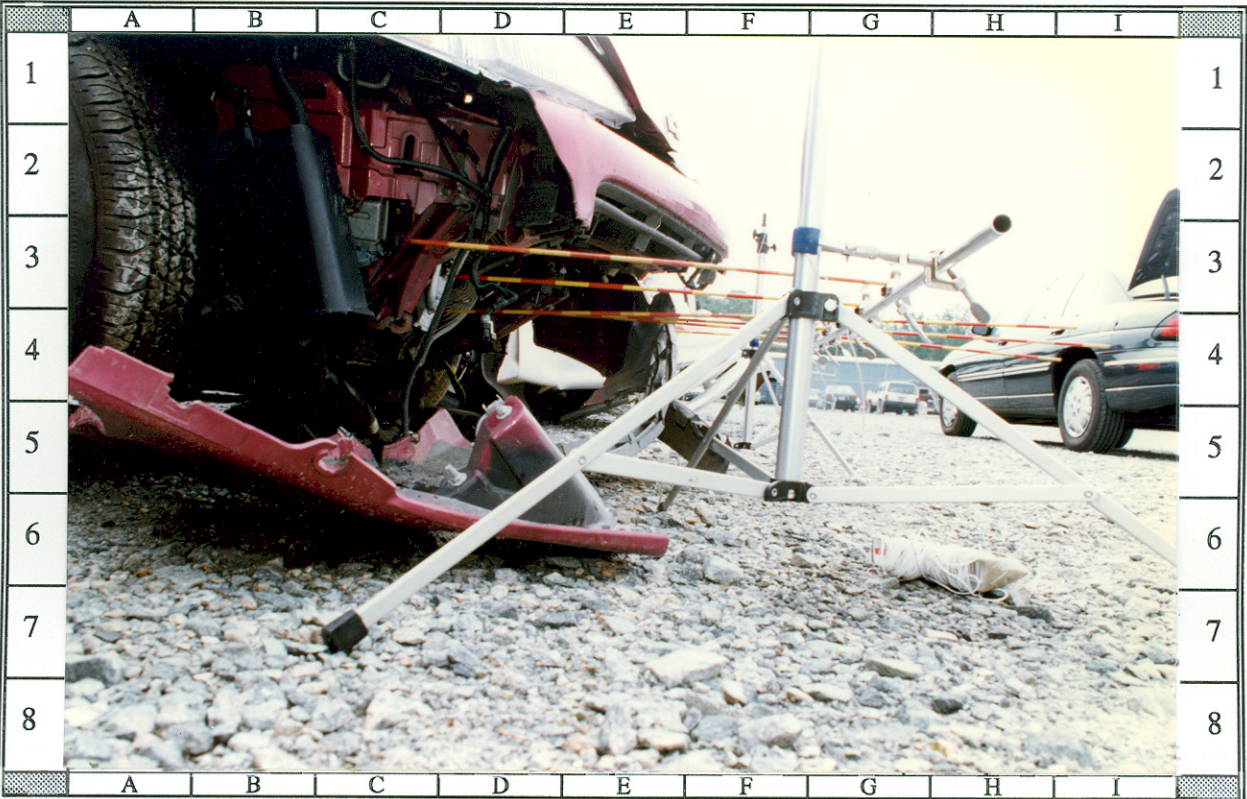
22: Close-up reference line view of Case Vehicle's below bumper crush from right

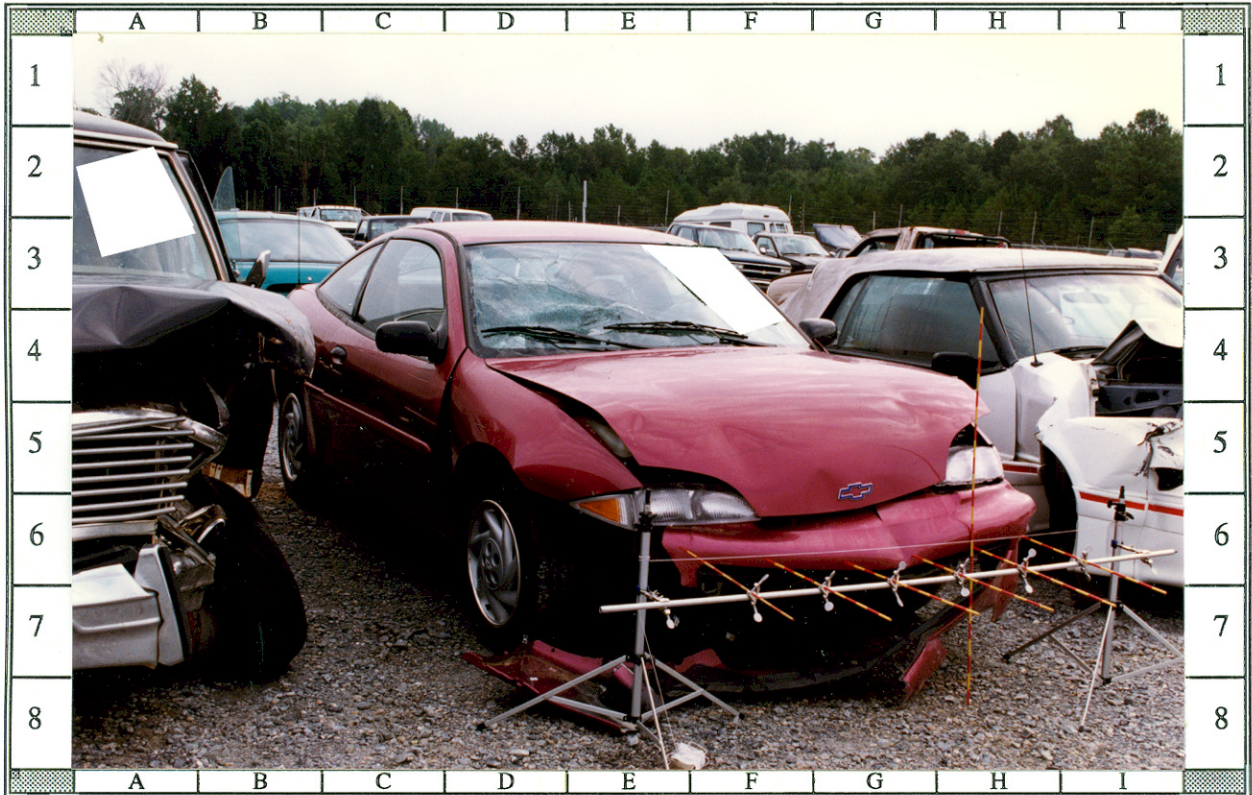
23: Case Vehicle's damaged front viewed from approximately 30 degrees right of front with contour gauge present at bumper level

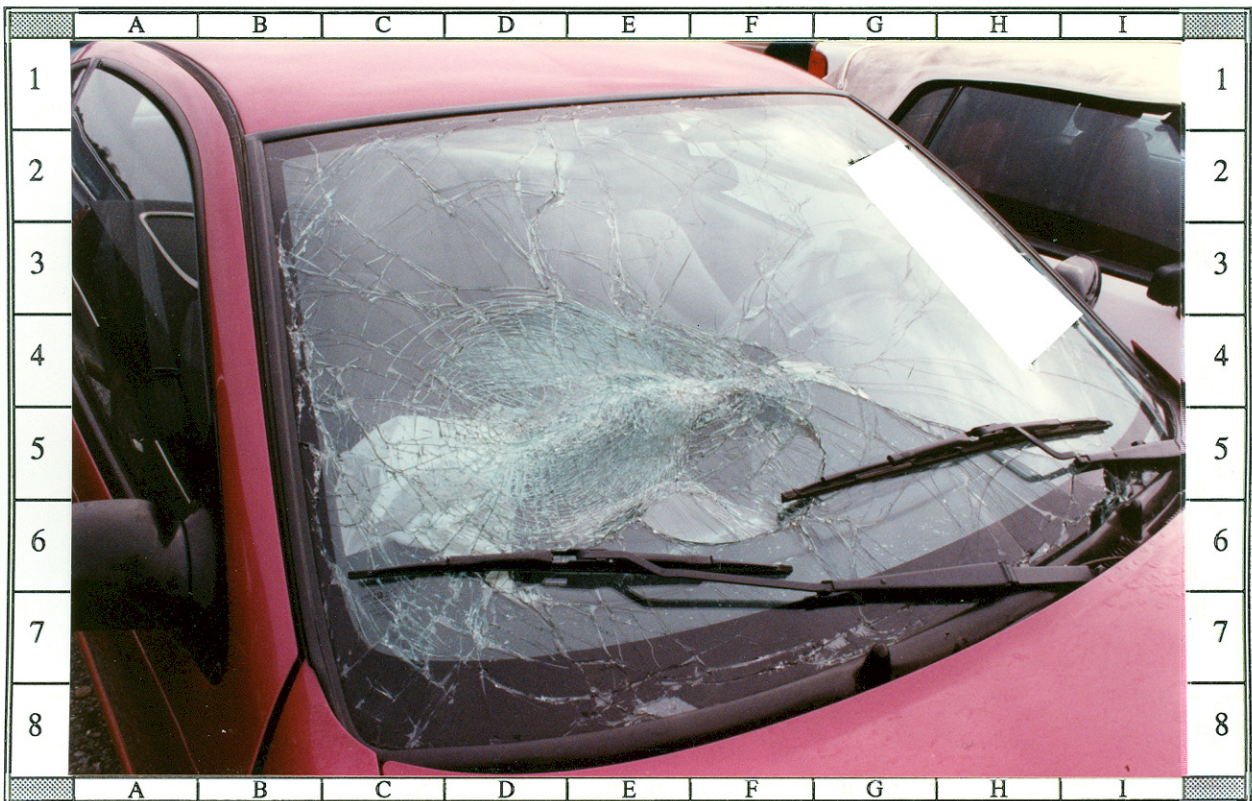
24: Close-up of Case Vehicle's damaged right windshield; windshield cracked from right front air bag module's cover flap

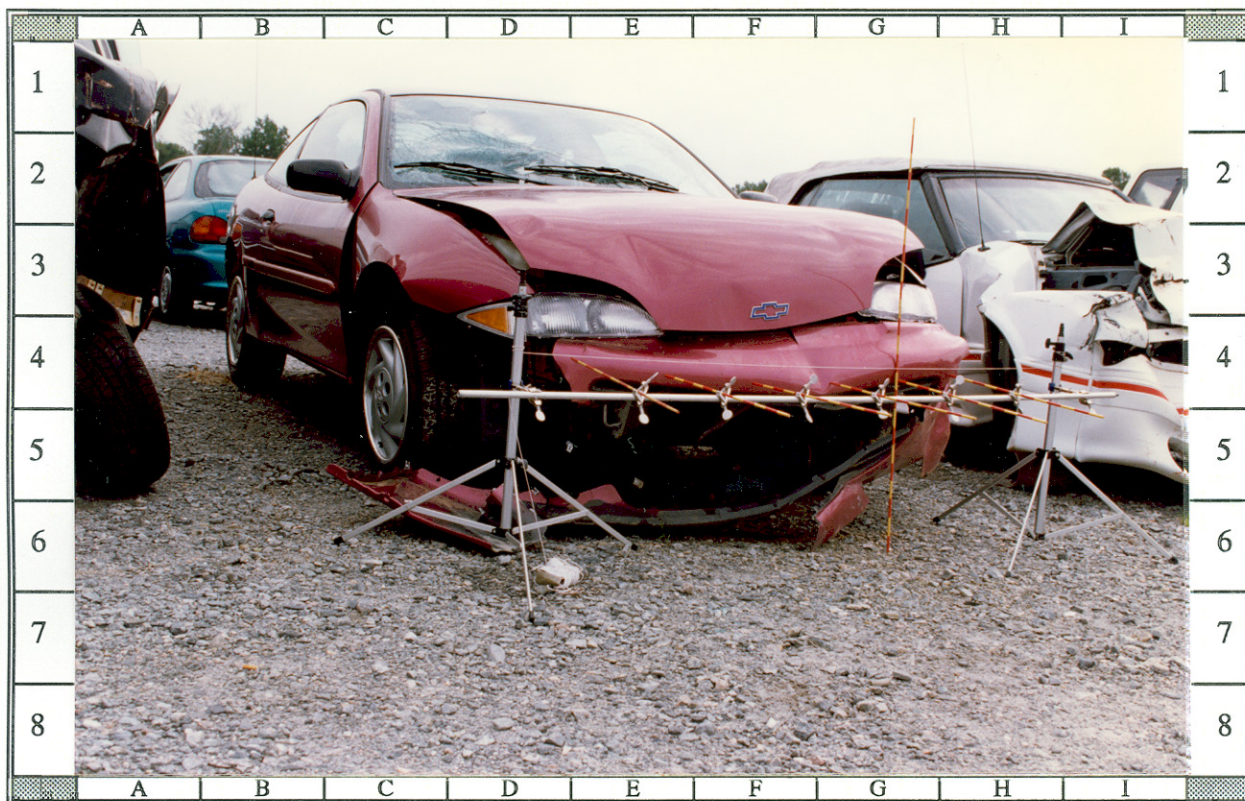
25: Case Vehicle's damaged front viewed from approximately 20 degrees right of front showing undercarriage damage below bumper

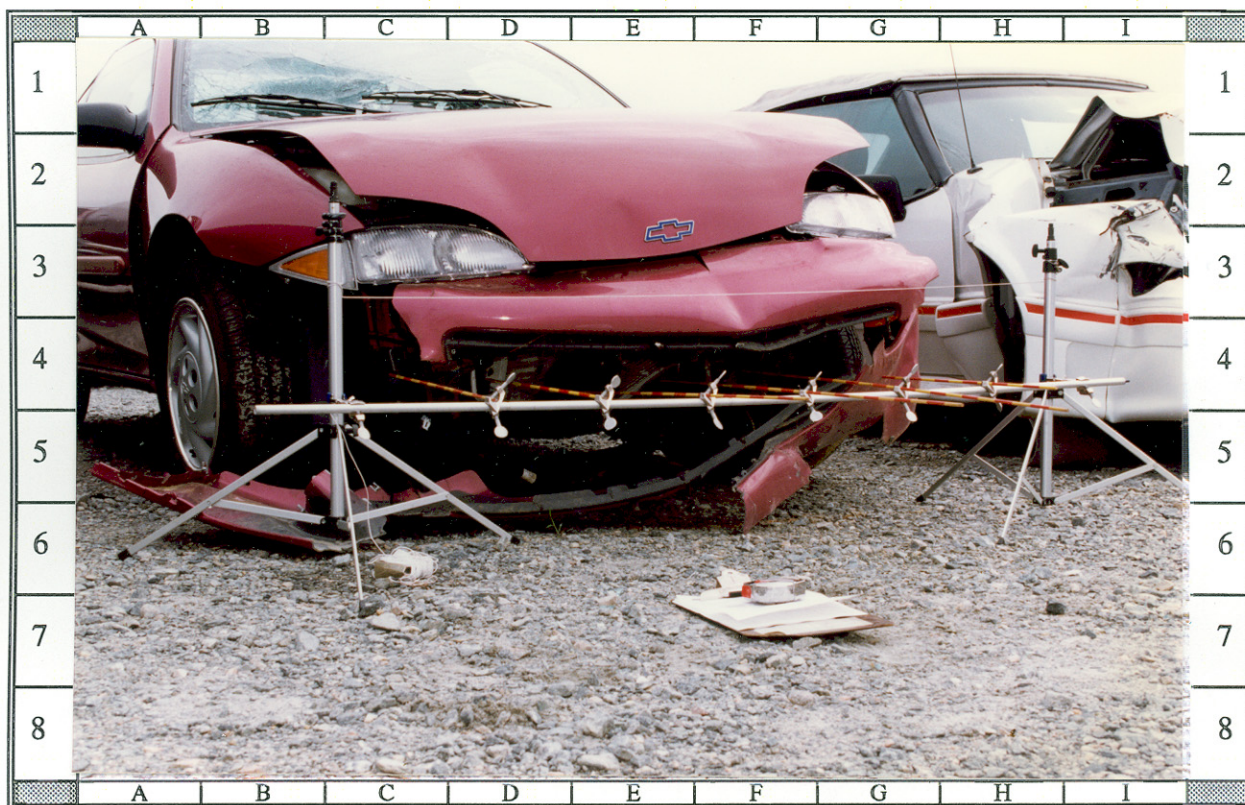
26: Closer-up view of Case Vehicle's extensive undercarriage damage with contour gauge present below bumper

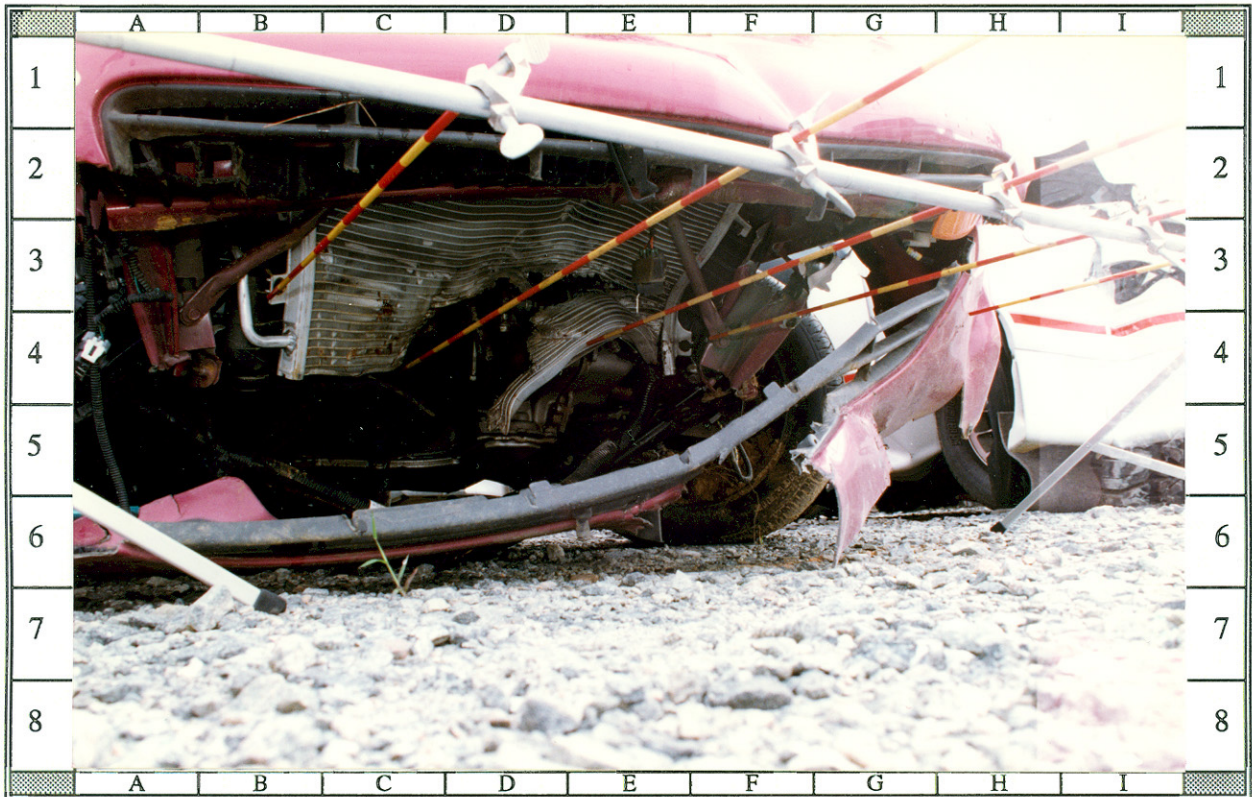
27: Close-up view of Case Vehicle's undercarriage damage with contour gauge present showing specifically torn radiator from impact with drainage pipe

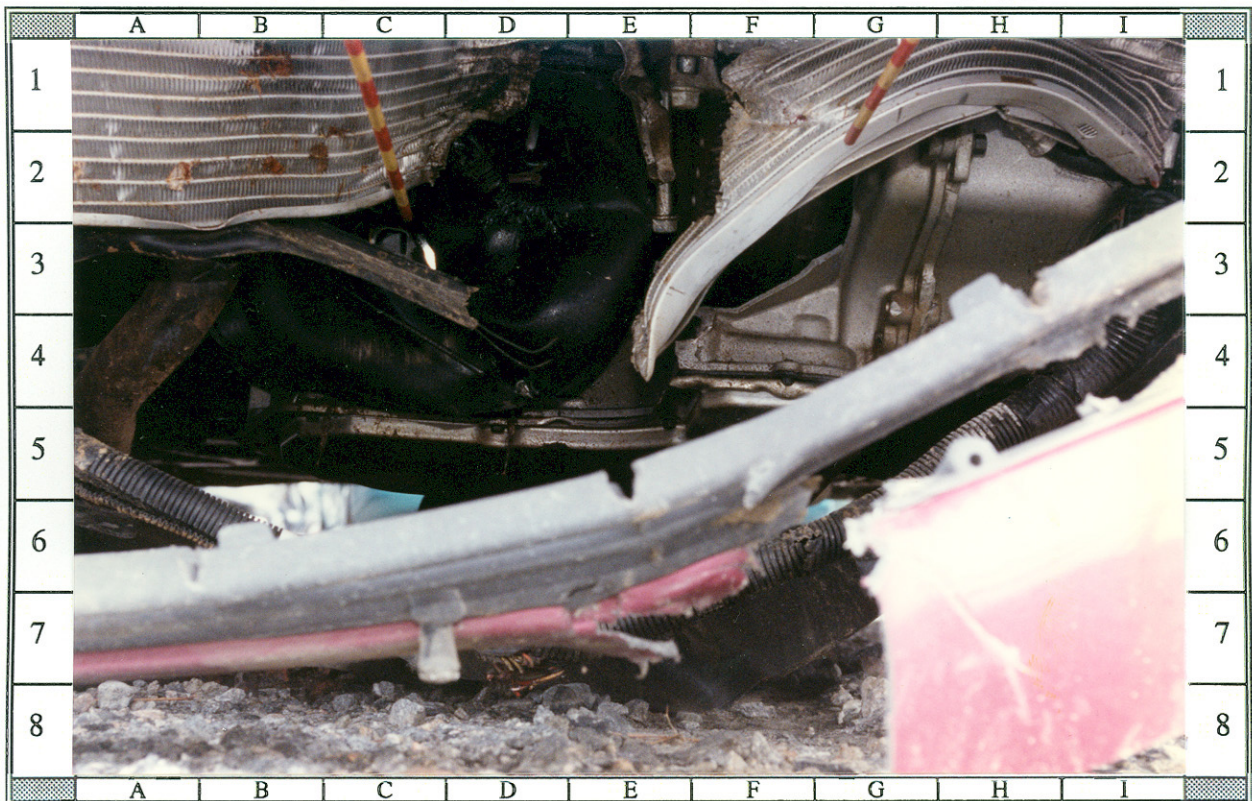
28: Closer-up view of Case Vehicle's undercarriage damage focusing specifically on torn radiator at C₃ and C₄ crush rods from impact with drainage pipe

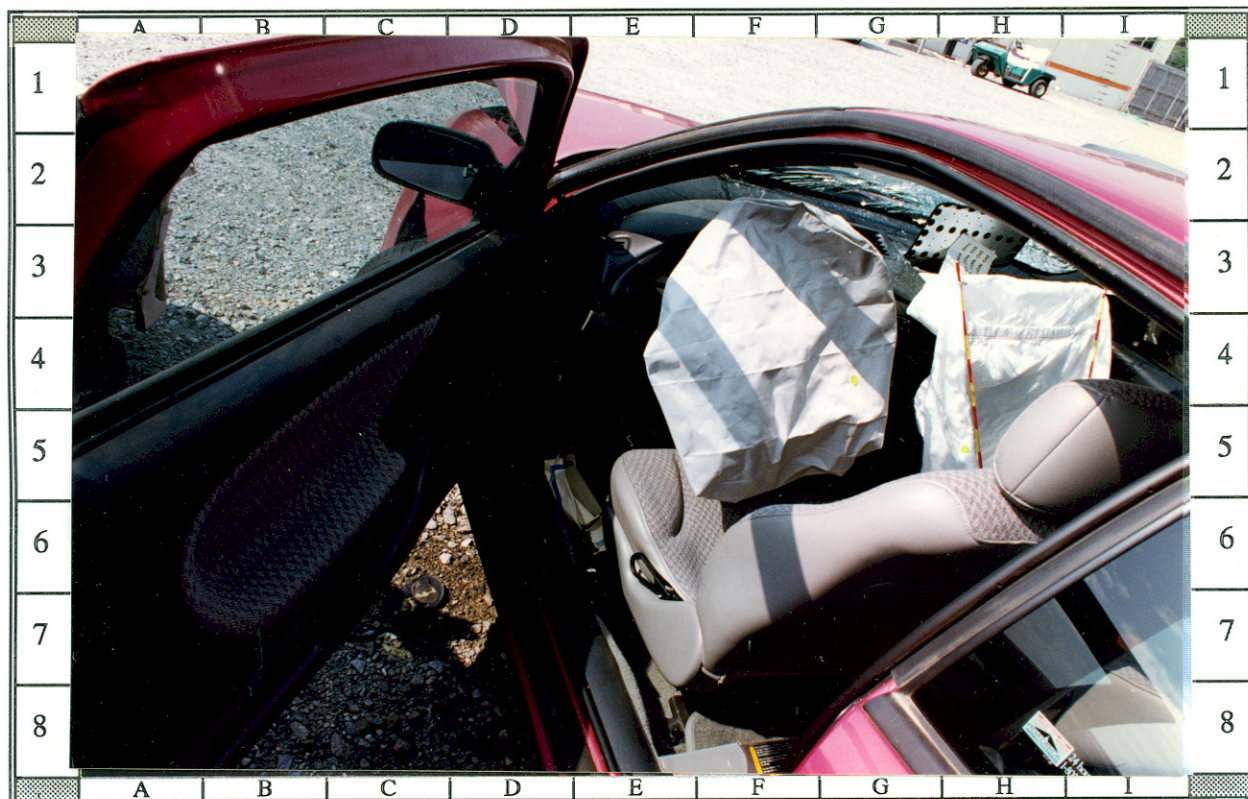
29: Interior surface of Case Vehicle's driver door panel and deployed front air bags

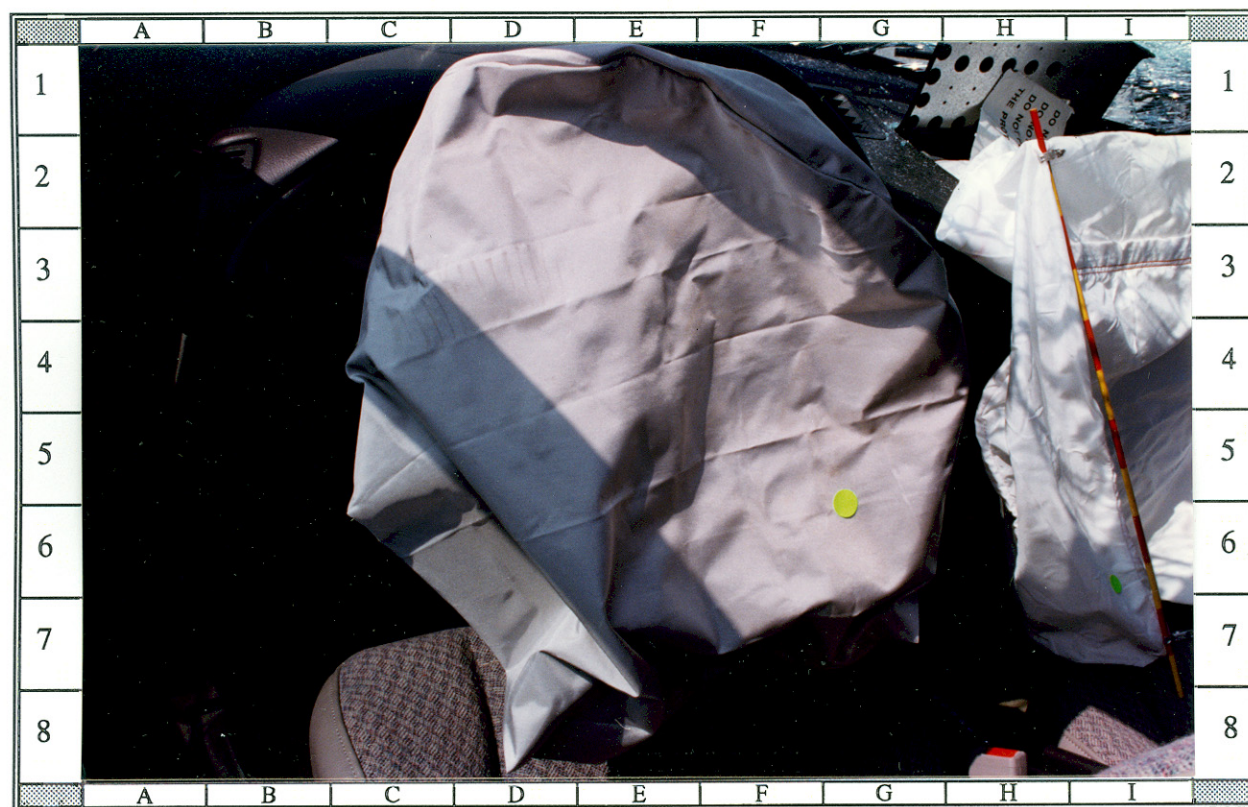
30: Case Vehicle's front seating area showing black vertical striations (cell G3) and contact evidence (i.e., green dot) to driver's air bag

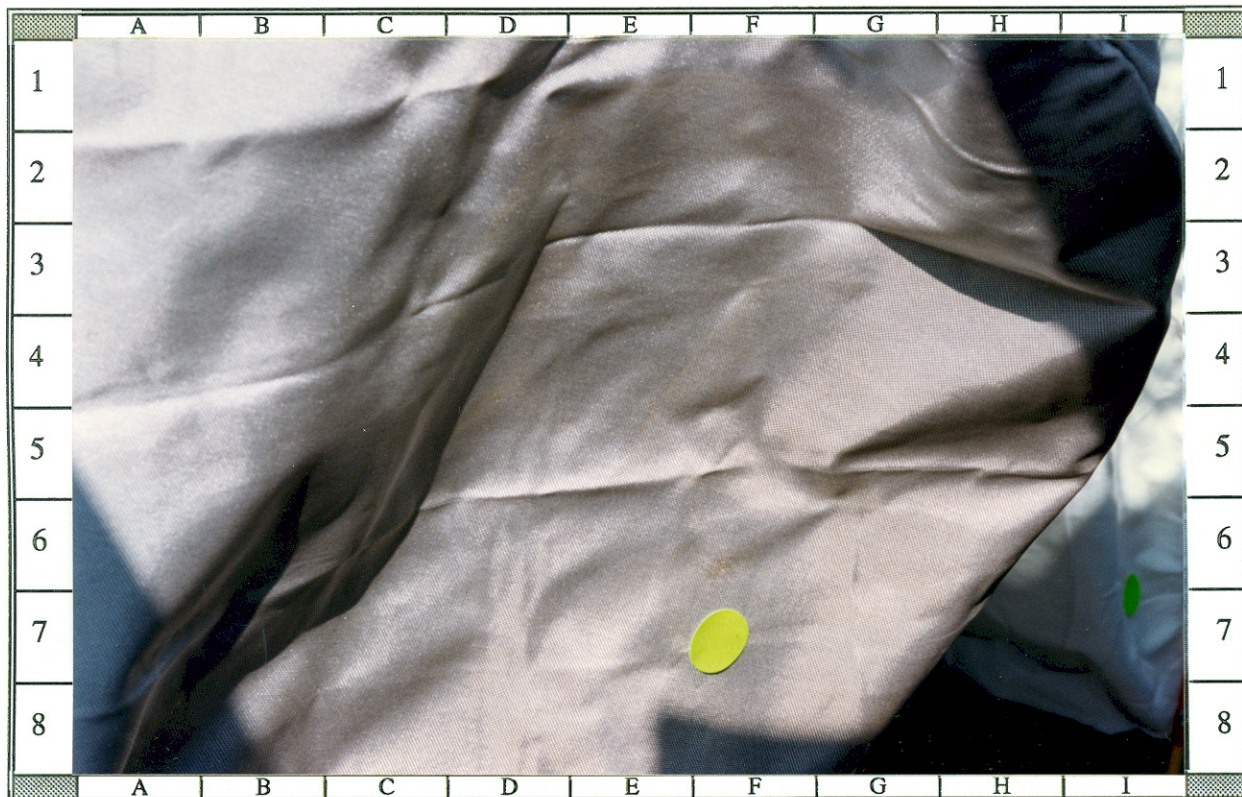
31: Close-up of contact evidence (skin and oil transfers--green dot) to Case Vehicle's driver air bag

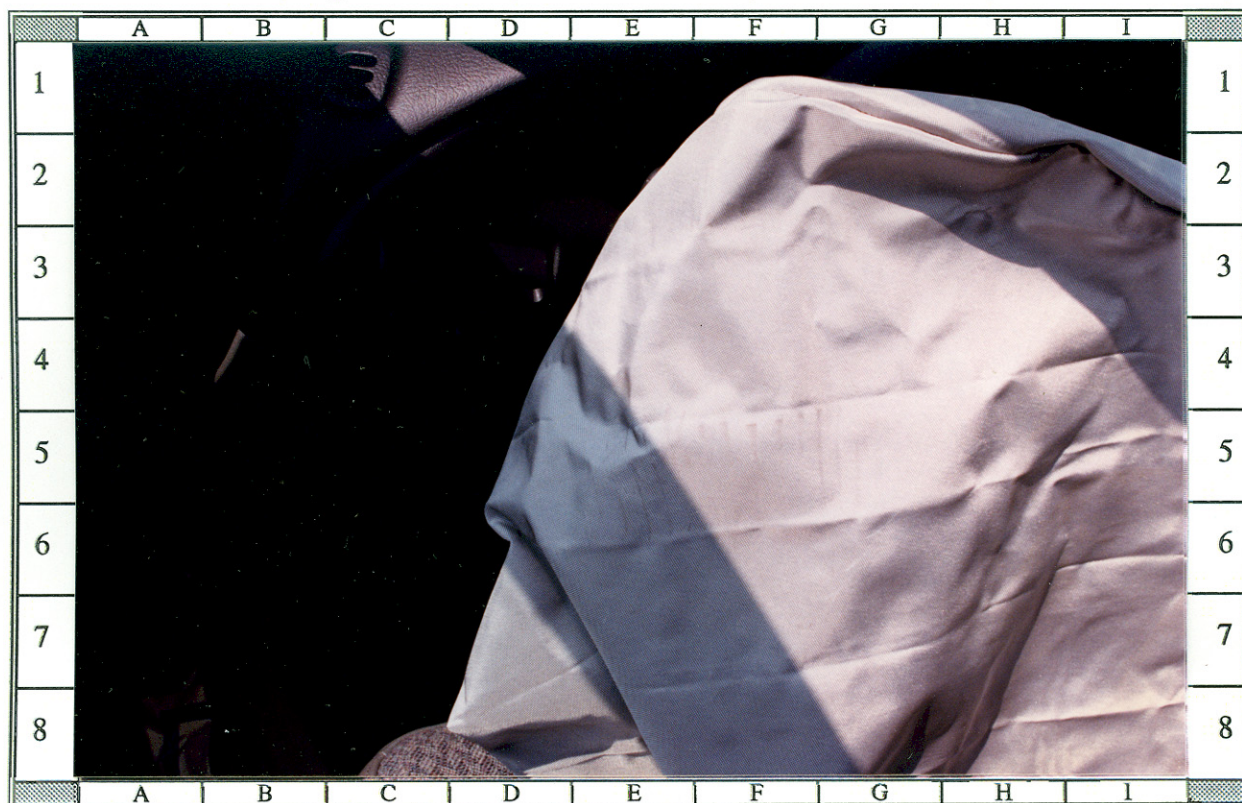
32: Black vertical transfer on Case Vehicle's driver air bag from driver side air bag module's cover flap (see Photo #33)
